CONTENTS

With the line of duty death of Firefighter Patrick Wolterman on December 28, 2015 our members, our department, and our community experienced the pain and grief that most departments and communities will never know. Our loss is secondary only to that of the Wolterman family. Other departments and other families have experienced losses. Each of those is as important and personal to them as Patrick is to us.

In the wake of that tragedy our members examined the causes and circumstances of that fire and worked with NIOSH to provide information which was published on July 14, 2017. NIOSH report # 2015-19 reports the facts and circumstances as gathered by NIOSH investigators. This report has been undertaken internally, considering the factors identified by NIOSH and applying them to our local practices.

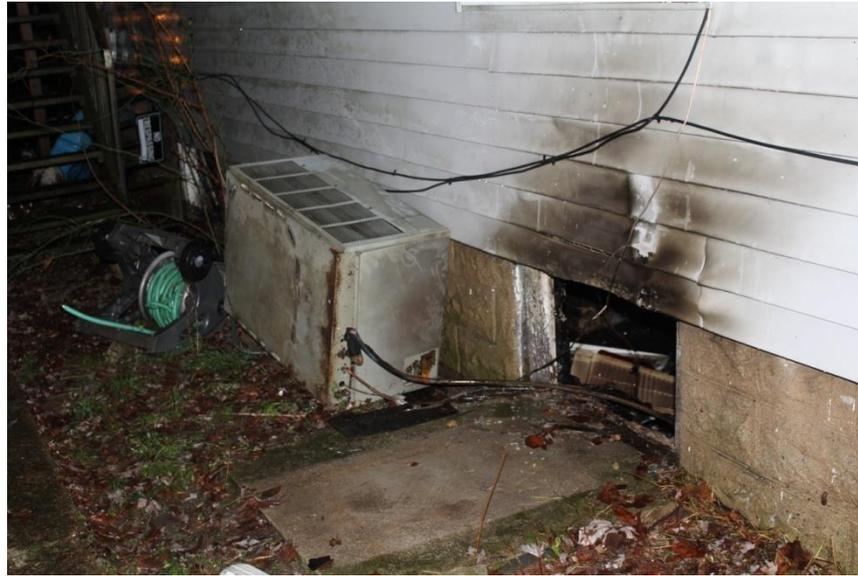
broke out the other B side cellar window. As E21 FAO approached the scene from the B side, he noted fire coming out of the B side cellar windows, and at **01:25:36** he radioed command on FG5, advising heavy fire in the basement. This was immediately acknowledged by B20.

Side B basement windows

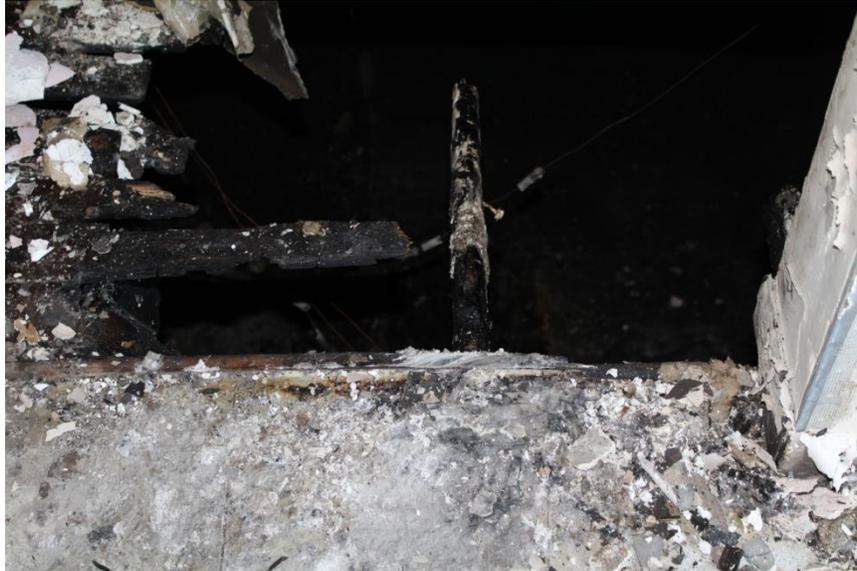
E24 OIC, still inside the structure near the hole in the floor, radioed B20 on FG5 at **01:28:18** and stated that he could hear a PASS alarm sounding in the basement. E21 crew, now operating the 2 ½" hoseline at the B side cellar window, also heard the PASS alarm in the cellar. Upon hearing this, E21 FAO and E21 FF1 left E21 OIC on the hoseline and went to the C side to assist the crews there.

Hole in the floor just to the right of the entry door

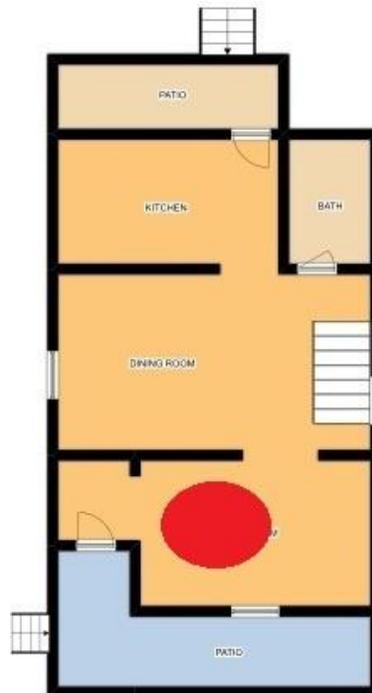
First Floor showing location of the hole

The floor layout for the first floor of the structure compared to the floor layout of the basement was not the same. As Q25 made entry, the floor would have been solid to the feel. It was found later that the floor at the entry was not above the basement but was above solid ground. The basement did not start until entry was made into the living room.

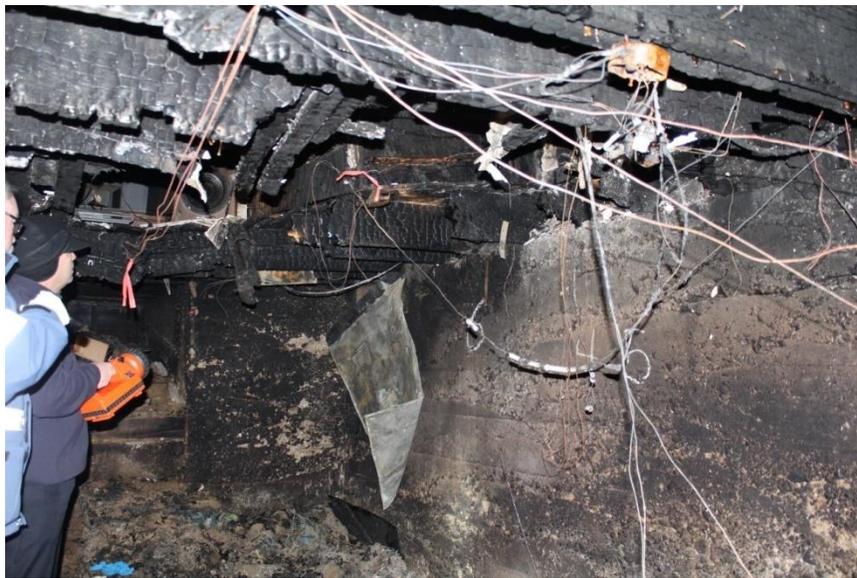
Location in the basement where Q25 FF1 was located

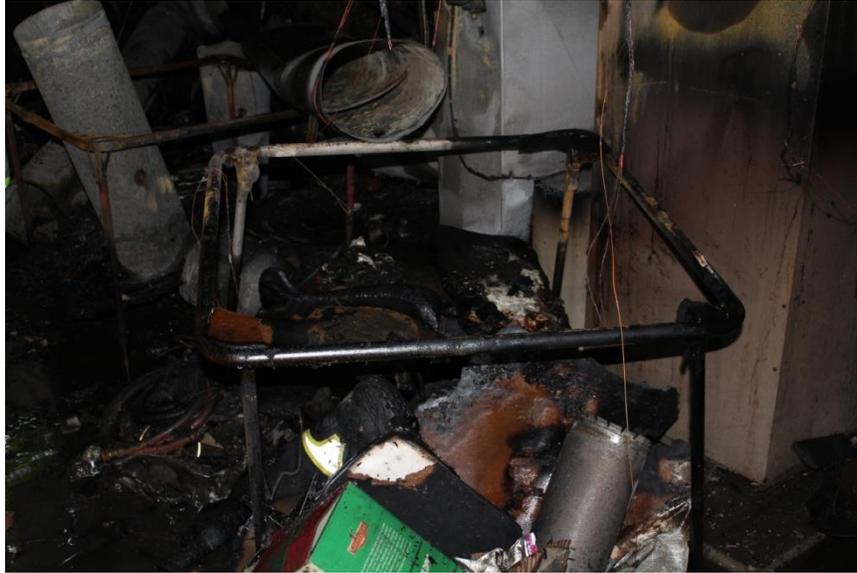
Debris in the basement containing Q25 FF1's boot

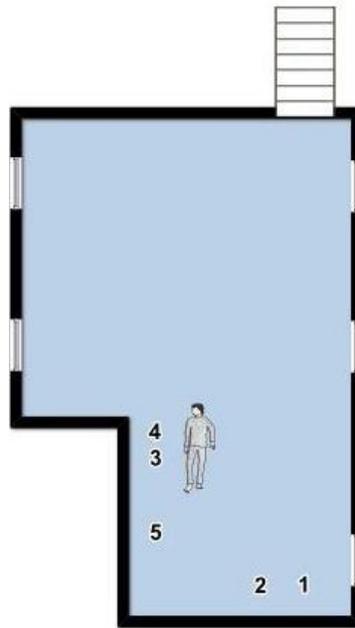
Basement with Q25 FF1 location found

#1 Boot #2 Helmet #3 Face piece #4 Hood #5 Glove

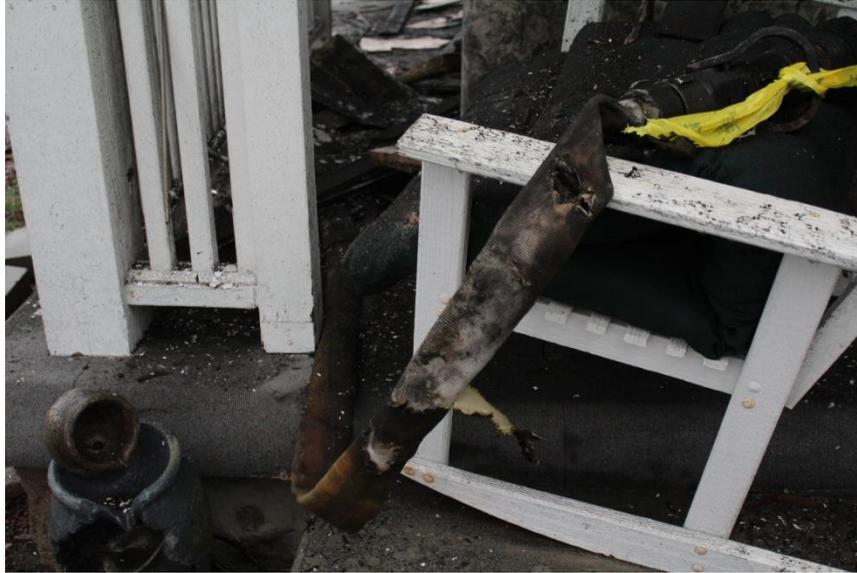
Q25 attack line with hole burned through the hose

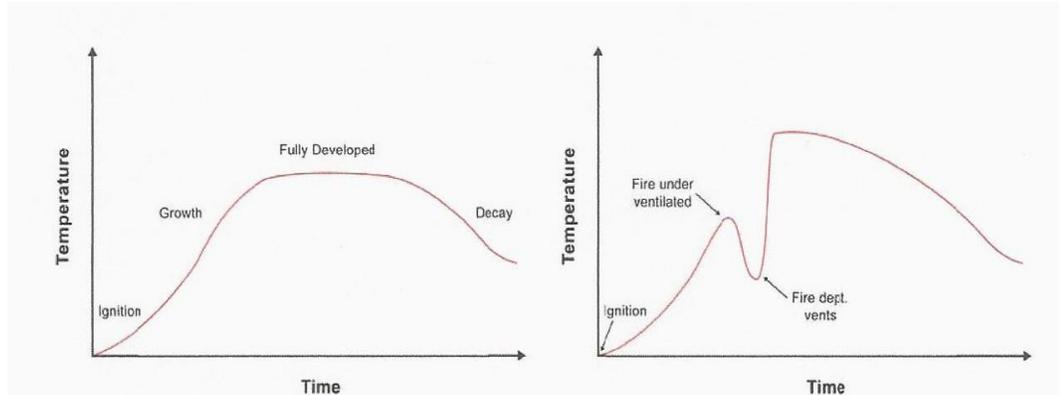
Graph on the left simulates a normal growth fire
Graph on the right simulates a ventilation limited fire

The Pater Avenue fire was a ventilation limited fire. As the fire in the cellar burned intensely and discovery was delayed, the oxygen level was depleted and high heat continued to generate combustible smoke. On opening the front door, the officer reported thick smoke, but not much heat. As Q25 FF1 breached the weak floor, the strong wind was blowing from the rear of the structure through the cellar and out the front door. This provided oxygen to the superheated and fuel rich smoke, creating an intense wind-driven fire.

Recommendation: The evaluation of fire and smoke conditions is a perishable skill and training must be maintained. HFD must continuously train its officers and acting officers in the skills of incident management and awareness. Extensive scientific research has identified the impact of ventilation on fire conditions, particularly research by NIST and UL focusing on modern fire attack, the basis for the SLICE-RS approach to fire attack operations. This information was introduced to the Hamilton Fire Department in April of 2014. Training must be developed in the changing environments that firefighters will encounter on today's fire ground. Department-wide hands-on training for this has been accomplished, though nearly two years after the Pater Avenue incident and over three years after introduction to the fire department.

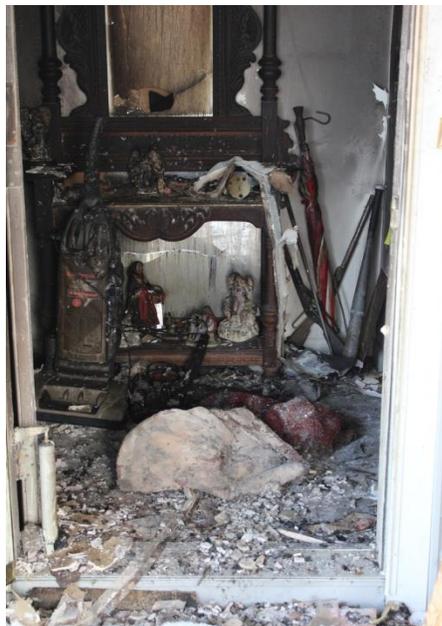
View of entry door Q25 accessed

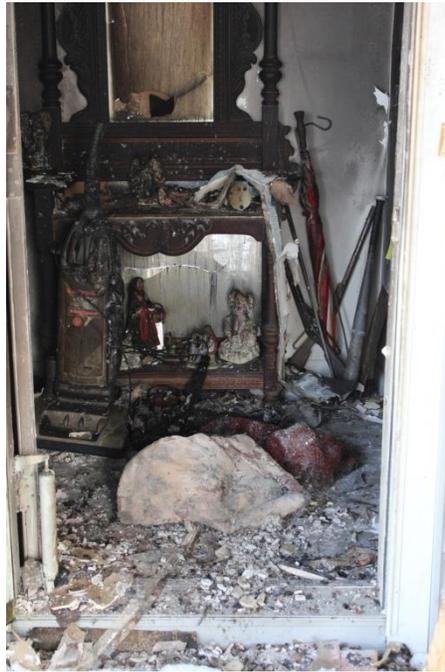
As Q25 OIC forced open the front door, he encountered a significant amount of black smoke spanning from the ceiling down to about a foot off of the floor. Q25 OIC recalled that the smoke was not hot. Q25 FF1 was on the nozzle and made entry ahead of Q25 OIC. Q25 FF1 and Q25 OIC entered "a couple of feet" where they quickly encountered a wall. As a result, the entry team made a right turn toward the D side of the structure which led them into the front room on the first floor. Q25 OIC recalled an immediate revealing of fire from the floor. He initially thought it was coming from a vent in the floor. Q25 OIC then stated that he "screamed for Q25

View of entry door Q25 accessed

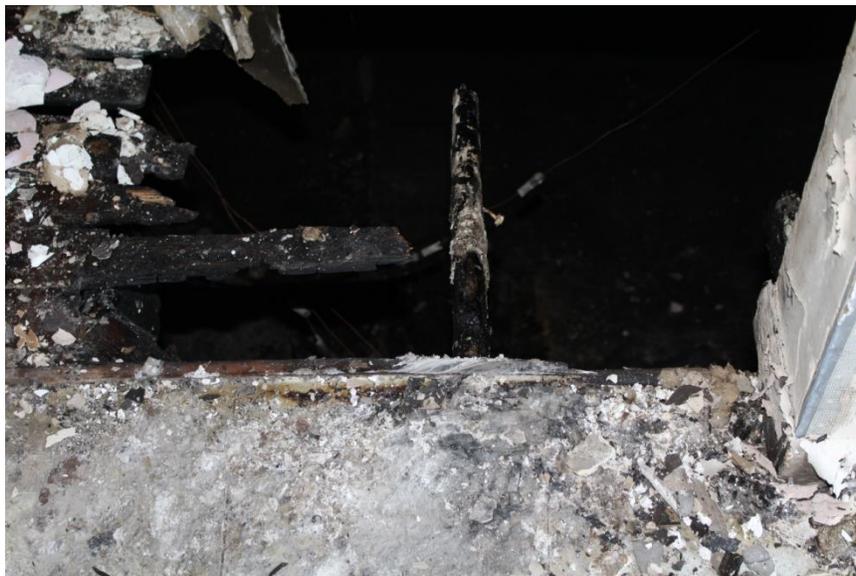
E24 OIC proceeded to the front door of the structure along with E24 FF1, following the original hose line from Q25. E24 OIC was able to follow the hose line through the door until both hands fell into a hole in the floor. E24 OIC received a burn on his left wrist at this time. E24 OIC pulled the hose line back towards him and found that it had burned through. E24 OIC started to sling the hose line around in the hole to try to extinguish any remaining fire. E24 OIC radioed that he had the nozzle at **1:27:10** (FG5) but needed a different one to be effective. E24 FF1 tried a couple times to press forward but E24 OIC informed him there was a hole in the floor.

Hole in the floor just to the right of the entry door

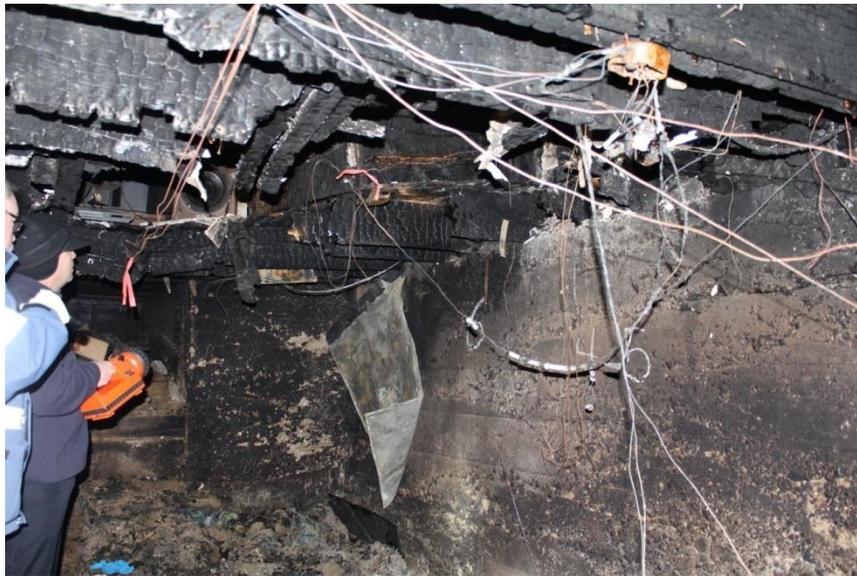
Location in the basement where Q25 FF1 was located

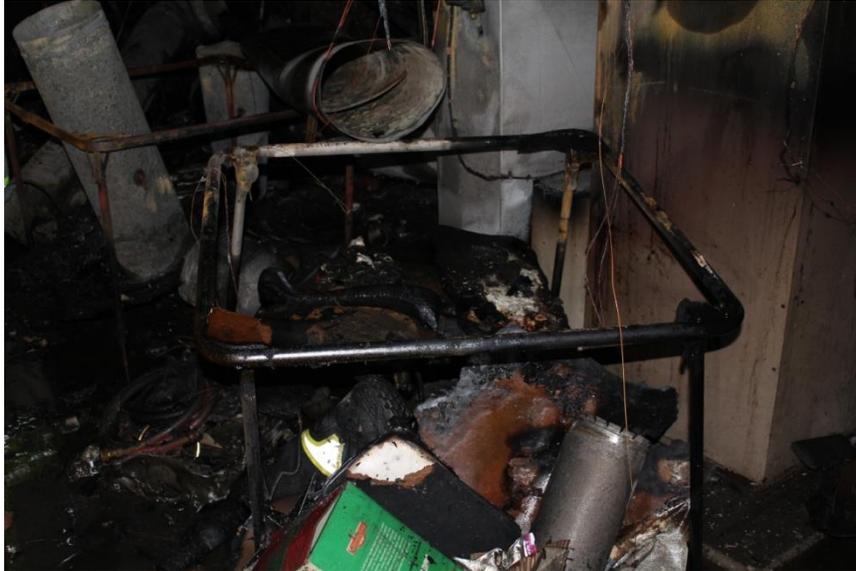
Debris in the basement containing Q25 FF1's boot
