CONTENTS

With the line of duty death of Firefighter Patrick Wolterman on December 28, 2015 our members, our department, and our community experienced the pain and grief that most departments and communities will never know. Our loss is secondary only to that of the Wolterman family. Other departments and other families have experienced losses. Each of those is as important and personal to them as Patrick is to us.

In the wake of that tragedy our members examined the causes and circumstances of that fire and worked with NIOSH to provide information which was published on July 14, 2017. NIOSH report # 2015-19 reports the facts and circumstances as gathered by NIOSH investigators. This report has been undertaken internally, considering the factors identified by NIOSH and applying them to our local practices.

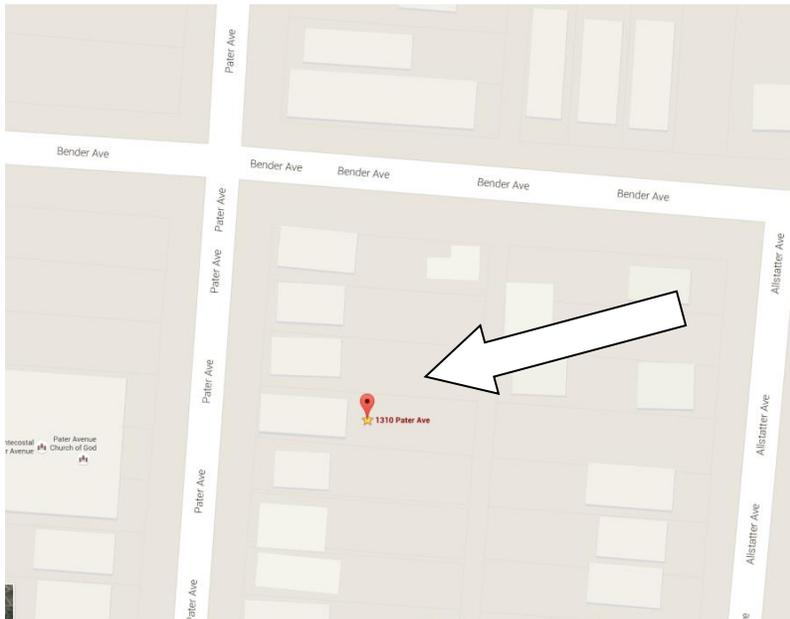
WIND DIRECTION:

The weather conditions were a factor in the incident that night. The wind was from the ENE with a wind speed of 11.5 MPH and wind gusts up to 30 MPH. The wind speeds at the time served the same as PPV (positive pressure ventilation) that night.

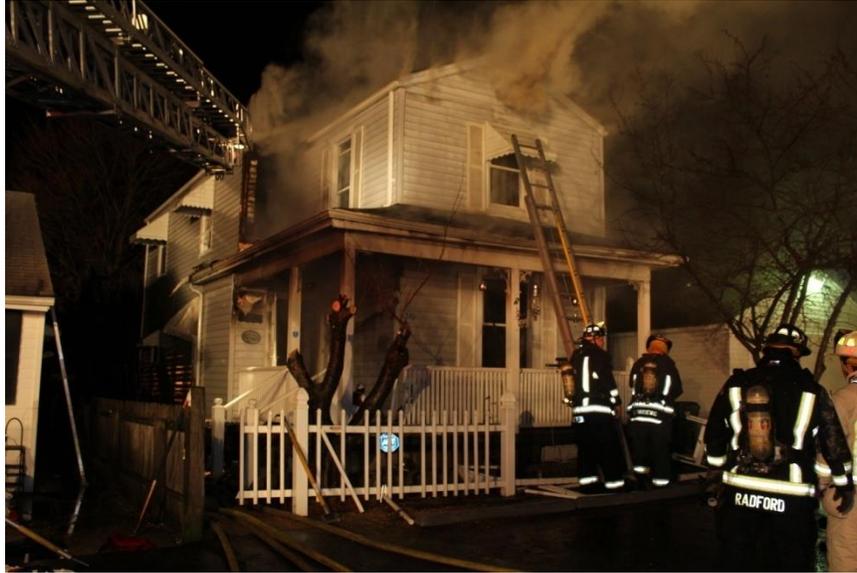
1310 Pater Avenue Side A

At 01:17:24, Q25 OIC advised on 9B that they were on the scene of a “two story wood frame” structure with “heavy smoke showing from two, three sides of the building. We’re going to do a 360. E26 please make our water supply or assist here on the corner.” Q25 OIC ordered Q25 FF1 to bring the thermal imaging camera (TIC) and forcible entry tools off the truck, and to stretch the 1 ¾” crosslay hoseline with the Task Force nozzle to the front porch. As Q25 OIC exited the apparatus, he was approached by an HPD officer who advised him that the neighbors stated that the residents could still be inside. Q25 FAO and FF1 stretched all five sections of the assigned preconnected hose, and Q25 FAO began stretching the supply hose to the hydrant. During this time, Q25 OIC called B20 on FG5 using his portable radio and asked if there was confirmation of people being out of the structure (01:18:12). B20 answered that there was no confirmation, and there may be people inside (01:18:23). As Q25 OIC began his size-up, he noted significant wind speed and no smoke from the rear (C side) of the building.

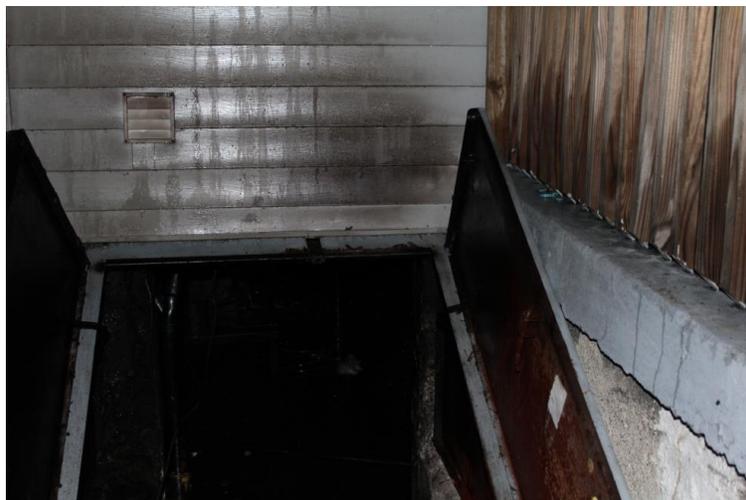
Cellar Doors Side C

As the above operations were occurring, E26 arrived on scene, and E26 OIC and E26 FF1 began to do a size-up by walking past the A side of the building and proceeding down the B side to the C side. E26 crew found the cellar doors on the C side, noting that one was in the fully open position. They then proceeded to open the other.

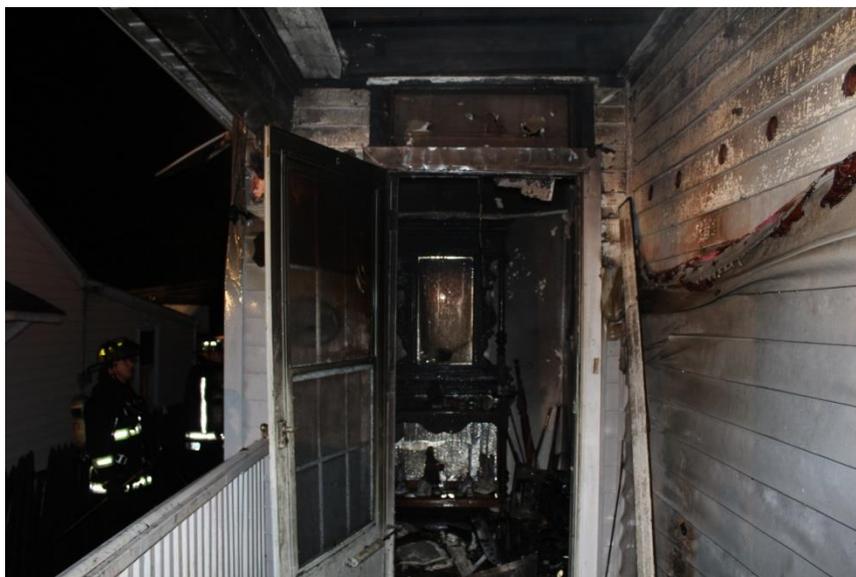
Door entered by Q25 Side A

At **01:21:40**, Q25 OIC called B20 on FG5 and advised that they had their two out (referring to the “two in-two out” principle of having adequate personnel on scene prior to entering a hazardous environment). He visually noted no active fire seen through the front windows, and stated that they were going to make entry on the A side of the structure. B20 also noted that he could see no visible flames at this point. Both the attack hoseline and the back up hoseline were charged, and Q25 forced entry through the locked front door using the halligan tool. Upon opening the door, Q25 OIC encountered significant black smoke from the ceiling down to about a foot off the floor, which he described as not hot and not pushing. Q25 FF1 took the nozzle and entered the structure through the front door, followed immediately by Q25 OIC.

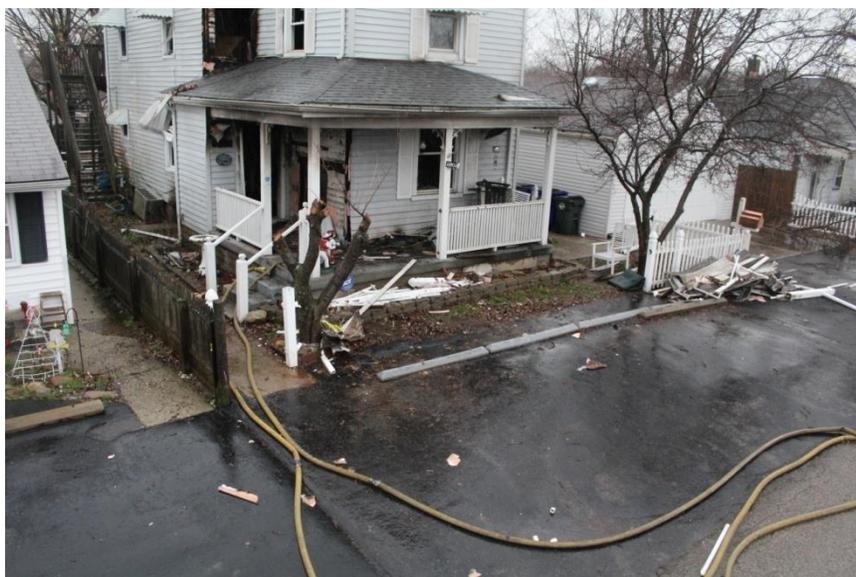
conditions. E24 OIC described the smoke as transitioning to deep brown/black under pressure, and heard Q25 OIC yelling to Q25 FF1 to open the nozzle. B20 stated that within a very short time after Q25 made entry, flames began shooting out through the front door and under the porch roof. B20 called Q25 on FG5 at **01:23:12** and gave the order "Let's back out, back out, back out!" E24 OIC was located outside near the front porch, and heard Q25 OIC calling for Q25 FF1, and at **01:23:27** E24 OIC called a Mayday on FG5, stating that there's a "guy that's still inside". B20 immediately acknowledged the Mayday, and E24 OIC followed this with another transmission on FG5 that "we have a firefighter inside, and it's flashed". T22 FAO, who was also near the porch, picked up the backup line and began directing a straight stream into the front door.

Two 1 ¾" hose lines advanced to the front door

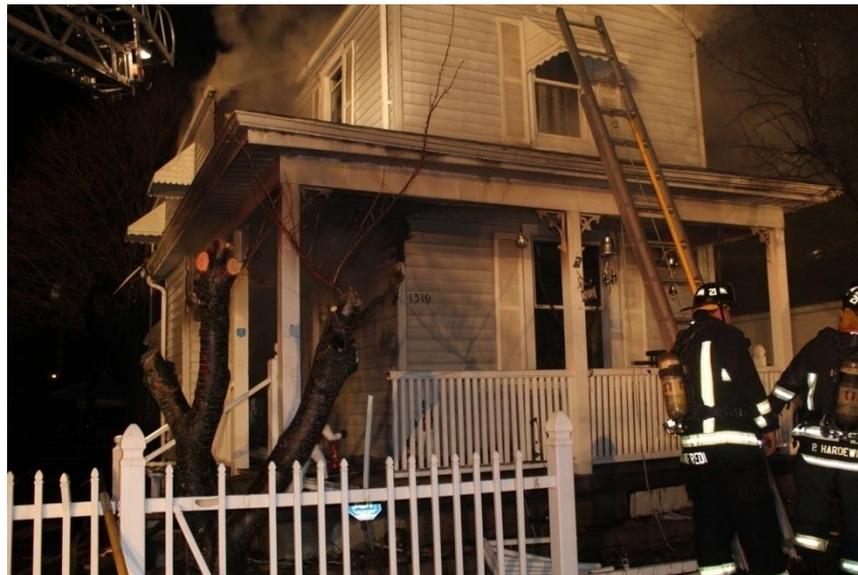
A Side of structure

Q25 OIC started his 360 on side A, moving clockwise down side B, where he noted "significant wind speed, at least 10 mph". Q25 OIC then reached the C side of the structure where he noted no smoke, stagnant or pushing, from the exterior on this side of the building. Q25 OIC stated that "all the smoke was from about the half way point of the house pushing out to the A side out into the street". Q25 OIC also noted an exterior hatch/basement access on side C. Q25 then went from side C back down the B side of the structure where he noticed two cellar windows near the AC unit. There was no evidence of smoke or flame from those windows at this time. Q25 OIC made his way back to the A side where he looked through the front porch windows and front door (the front door had a glass window), neither of which showed any active fire.

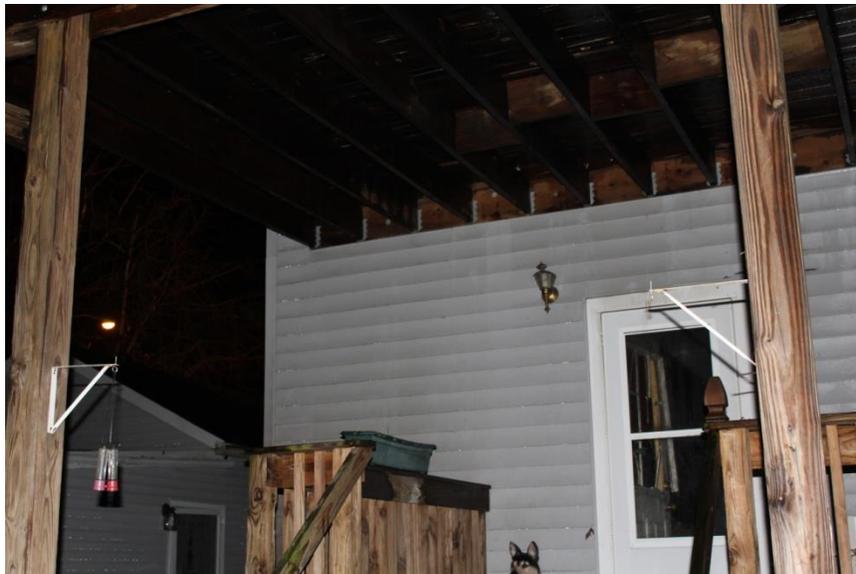
Door accessed by T22

T22 OIC and T22 FF1 walked to the C side of the structure where they encountered a first floor rear door. At about this time, T22 FAO heard Q25 FF1 had fallen through the floor. T22 FAO grabbed a hatch ladder off Q25 and placed it against a fence on the B side in case they needed it to extricate Q25 FF1. T22 OIC told T22 FF1 "to take the back door." T22 FF1 first tried to turn the handle with no success. T22 FF1 used the halligan to break out the glass of the rear door. T22 FF1 reached in to unlock the door while T22 OIC was holding open the storm door. T22 OIC stated once the door was forced, they encountered thick black smoke that was ten to fifteen inches from the floor.

T22 OIC told T22 FF1 that they were not going in the structure. T22 OIC felt they were disturbing the thermal layers so he closed the storm door and they exited the rear porch.
